Final  
Technical Summary Report  
of  
RESEARCH AND DEVELOPMENT PROGRAM  
OF  
THERMIONIC CONVERSION OF HEAT TO ELECTRICITY

Volume I

June 30, 1964

GENERAL ELECTRIC COMPANY  
SPECIAL PURPOSE NUCLEAR SYSTEMS OPERATION  
VALLECITOS ATOMIC LABORATORY  
P. O. BOX 846  
PLEASANTON, CALIFORNIA

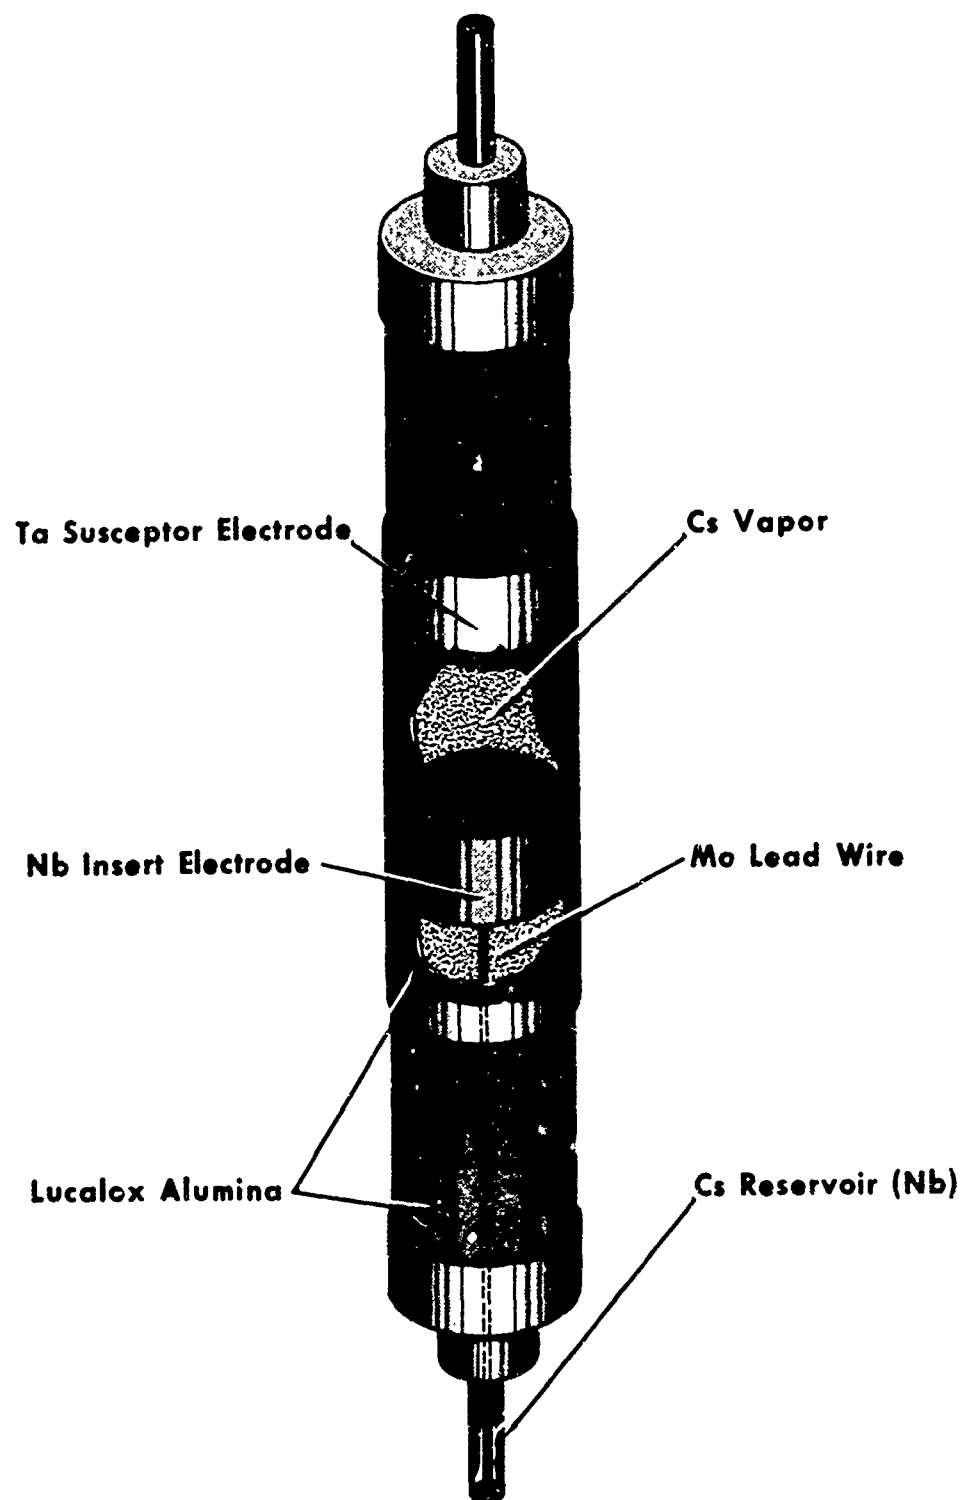
FIGURE II-1. LUCALOX ALUMINA CONFIGURATION  
FOR CONDUCTIVITY EXPERIMENT

Five tubes of Lucalox alumina were obtained from the Large Lamp Department, General Electric Company. A tube is shown in Figure II-1. The tubes were about 1/2-inch diameter, 0.030-inch wall thickness and 4 inches long. Each end was sealed to a niobium end piece which lead to a 1/8-inch niobium tube about 1 inch long. A 0.394-inch long niobium cylinder was placed in the center of the Lucalox tube to serve as one electrode. The other electrode was a 1.05-inch long coating of tantalum metal applied to the exterior of the tube by flame-spraying. Each tube was checked upon receipt for vacuum tightness by the He mass spectrometer method; all proved leak-free.

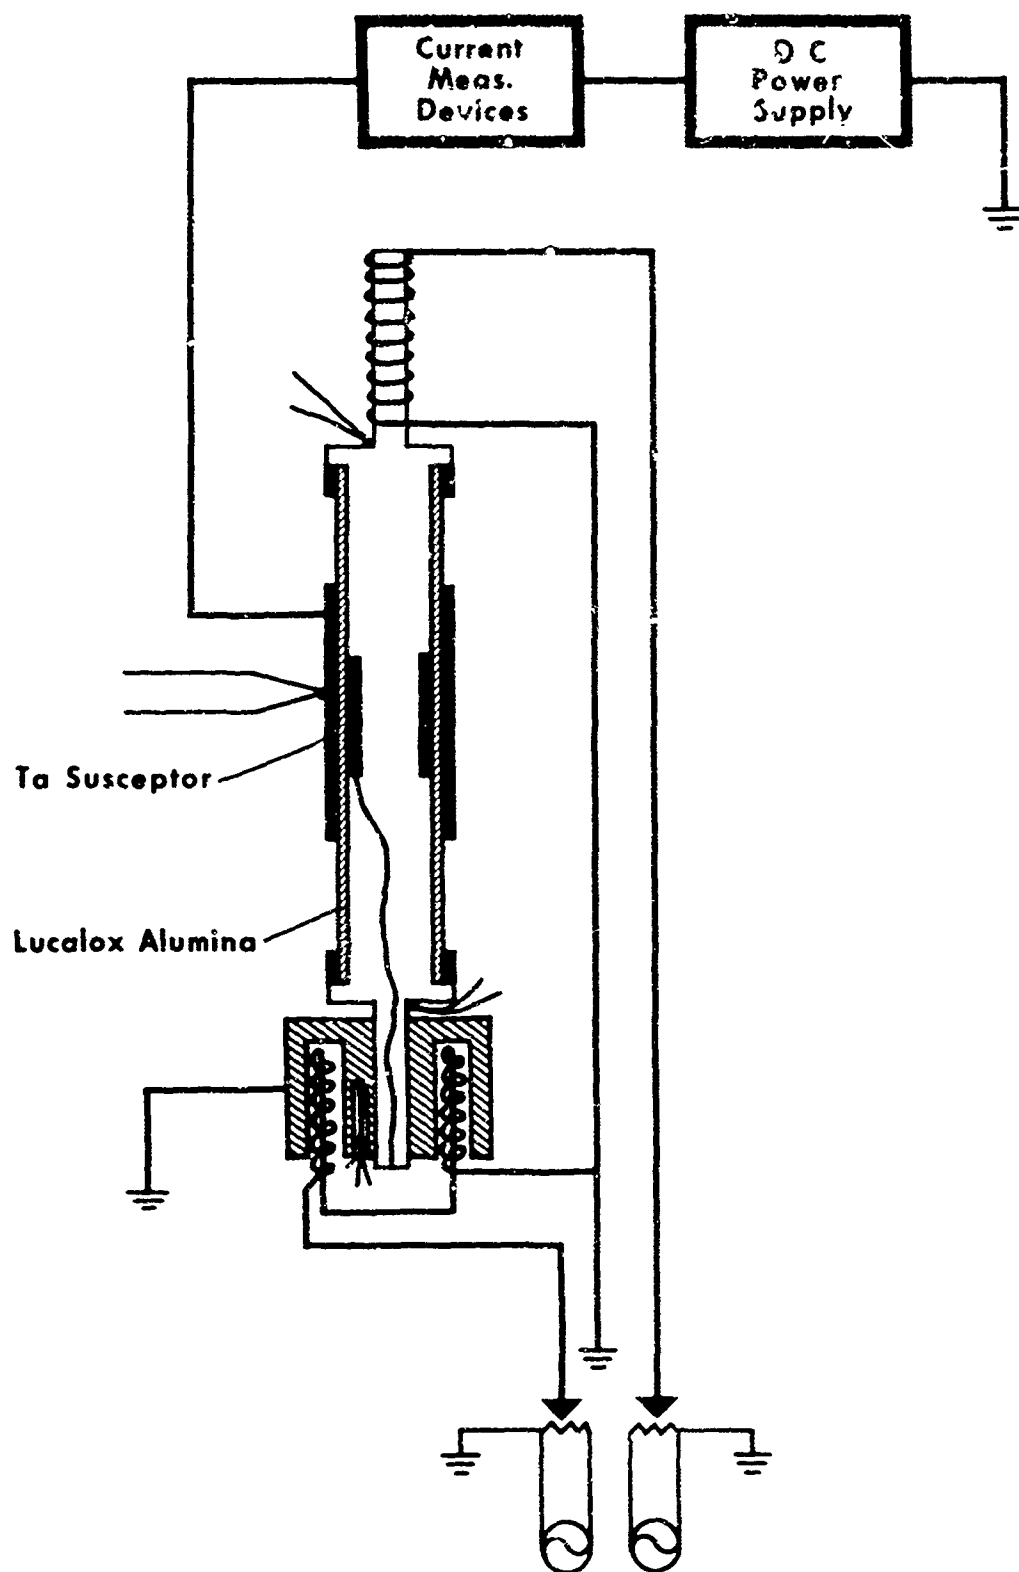
FIGURE II-3. SCHEMATIC OF CONDUCTIVITY EXPERIMENT

Currents above  $10^{-7}$  amp were measured using a potentiometer and a 198 ohm resistor in series with the specimen. Between  $10^{-10}$  and  $10^{-7}$  amp, an electrometer was used. Below  $10^{-10}$  amp, currents could not be measured reproducibly. The error in current measurement was less than 1% above  $10^{-7}$  amp and about 20% between  $10^{-10}$  and  $10^{-7}$  amp. The observed resistance values are given in Figure II-4 for the two specimens. Points on Figure II-4 designated by a letter E are values determined using the electrometer.

The voltage across the specimen was varied between 0 and  $\pm 6.7$  volts using a precision rheostat and batteries; it was varied between -400 and +150 volts using a dc power supply with about 0.01% ripple. Some volt-amp curves are shown in Figure II-5. When the Ta electrode was made positive, a short transient effect was noted with each increase in voltage; the current across the specimen would rise to some initial value and then drop to about 1/2 that value over about 10 seconds (at 1250°C); no further change with time would occur. The curve in Figure 5 labeled 918°C shows non-ohmic behavior typical of that observed for low cesium pressures.

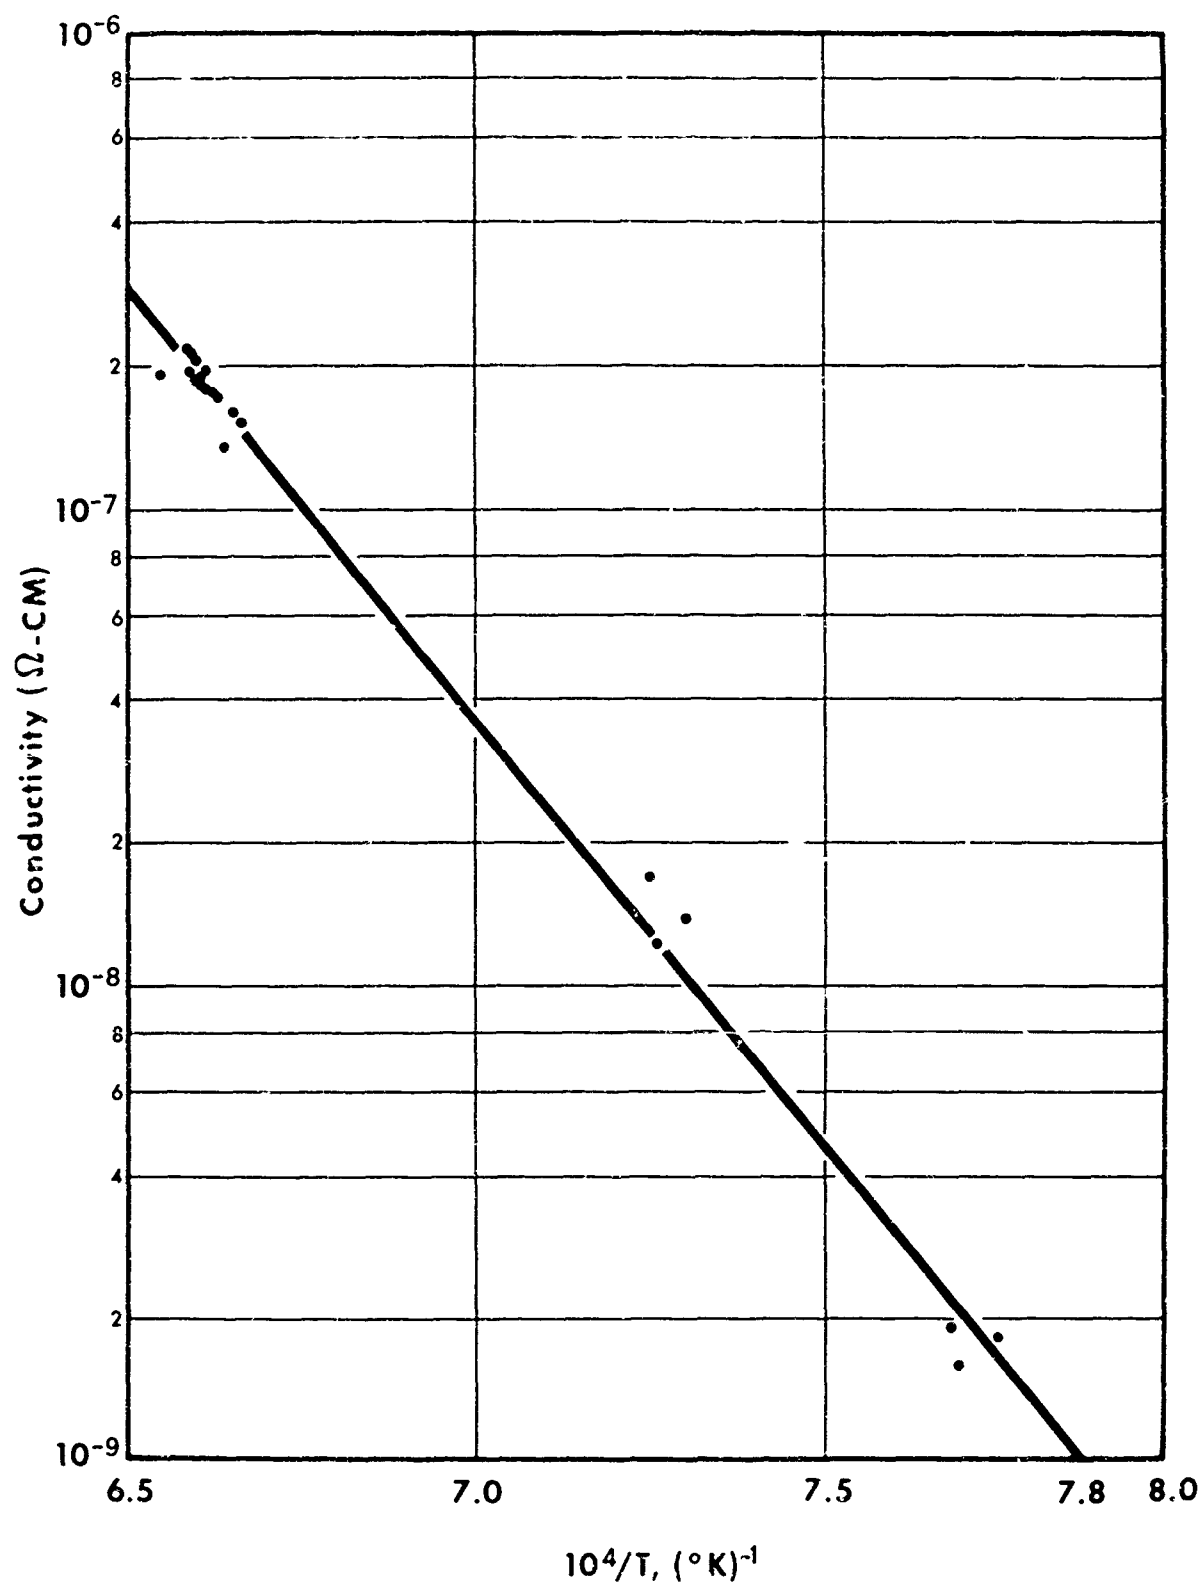
FIGURE II-7. TEMPERATURE DEPENDENCE OF ELECTRICAL CONDUCTIVITY FOR LUCALOX ALUMINA

The activation energy associated with the conductivity of Lucalox alumina (Figure II-7) is 3.55 electron volts between 1020 and 1200°C. The same activation energy (slope) was observed for both Lucalox tubes in the high temperature regime of Figure II-4. The low temperature activation energy from Figure II-4 is 2.32 ev. The high temperature values are similar to those obtained by Pappis and Kingery on polycrystalline alumina under  $10^{-10}$  atmospheres oxygen pressure.<sup>3</sup> The temperature at which transition to the higher activation energy conduction mechanism occurs was observed to be about 1520°C by Pappis and Kingery, while about 1000°C was observed in this study. The difference may be due to lower impurity concentrations in the present specimens; however, Pappis and Kingery did not present detailed analyses of their specimens for comparison.

Assuming this figure to be representative of intrinsic conduction a corresponding band gap of about 11 eV is found. Those authors found no activation energies higher than 3.6 eV for polycrystalline alumina with temperatures up to 1777°C. That observation is confirmed by the present study for temperatures up to 1250°C. The conductivity of polycrystalline alumina was apparently impurity dominated for both studies.

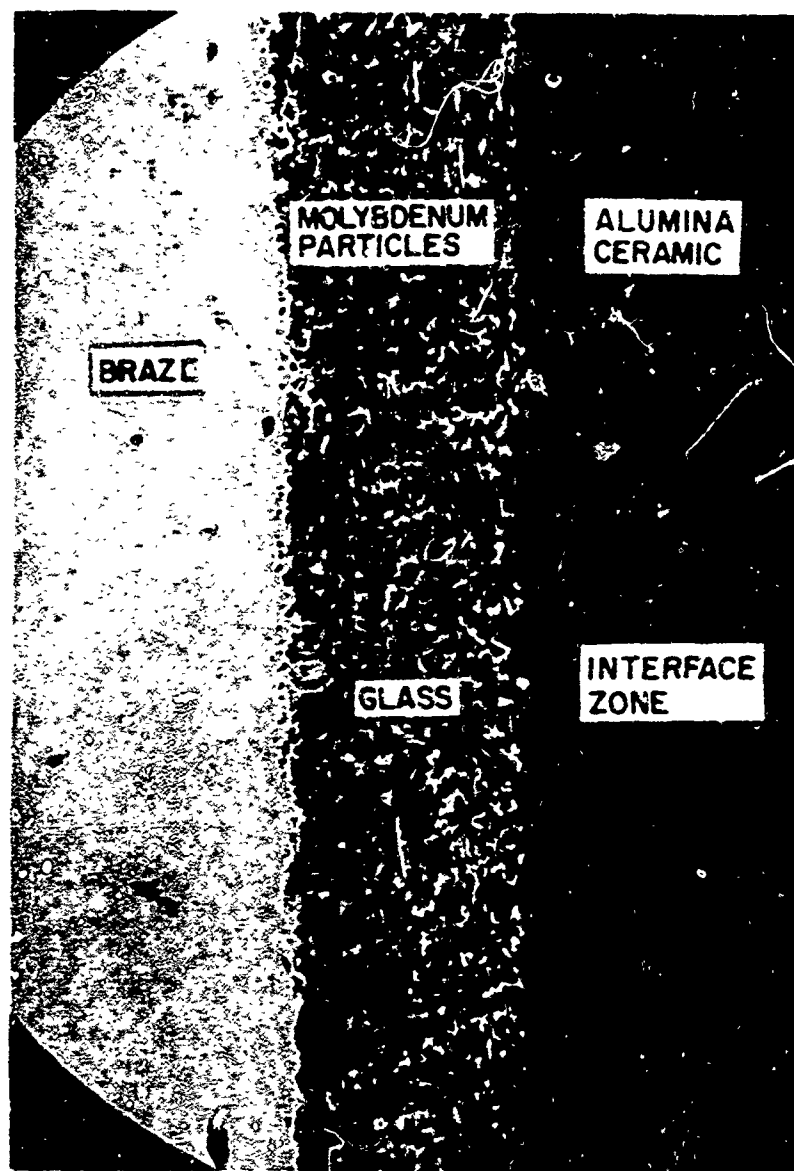
Figure III-1

related to this point as well as other reactions during metallizing have been reported by Cole.<sup>6</sup>) It is the manganese in the above discussed coating, as well as the fluxing oxides present in a so-called high-alumina ceramic, which promote adherence. Consider the specific case of metallizing of a high alumina body having a composition of 96 w/o (weight percent) alumina and 4 w/o other oxides. During sintering of the metallizing coating, the dew point of the hydrogen atmosphere is maintained sufficiently moist to insure oxidation of the manganese. The resulting manganous oxide then reacts: (1) with alumina forming manganese-alumina compounds, and (2) with the fluxing oxides of the ceramic, producing a glassy phase which fills the interstices of the sintered molybdenum coating and serves to strongly lock it to the ceramic. A photomicrograph of such a coating on a high alumina ceramic is shown in Figure III-1. The reaction products mentioned can be seen in this illustration.

Typical Metallized Ceramic

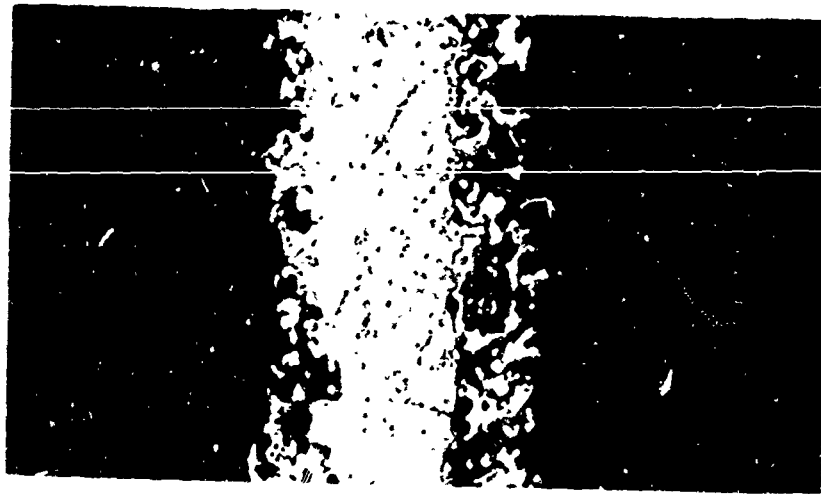
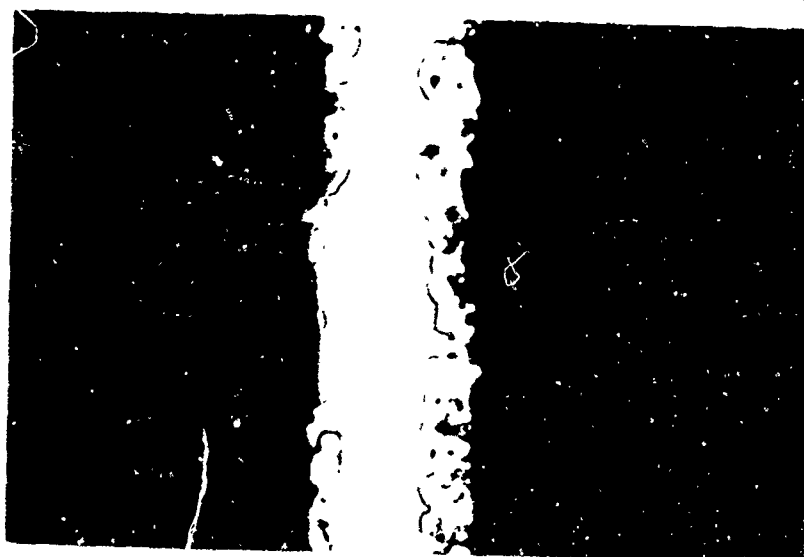
Figure III-2

1680°C

Leaker

1760°C

Vacuum Tight

1850°C

Photomicrographs of Ceramic-to-Metal Seals (500X)

It was observed that the metallized layer of high fired ( $1850^\circ\text{C}$ ) metallizing mix No. 1 is quite dense. This is attributed to the fluidity of the eutectic composition bonding oxide, which permitted good sintering of the molybdenum particles. It was theorized that the bonding strength of such a structure (where the molybdenum layer approaches a single sheet with a consequent reduction in mechanical interlocking to the substrate), might be less than that produced in a structure possessing more oxide constituent in the metallizing area. Metallizing mixes Nos. 18, 21 and 36 contain bonding oxide compositions having increased alumina contents in an attempt to impede densification of the metallic phase. Although a reduction in molybdenum particle sintering can be noted in the specimen shown in Figure III-3A (mix No. 18 -  $1800^\circ\text{C}$  sinter), it was not vacuum tight and failed at the interface. The higher

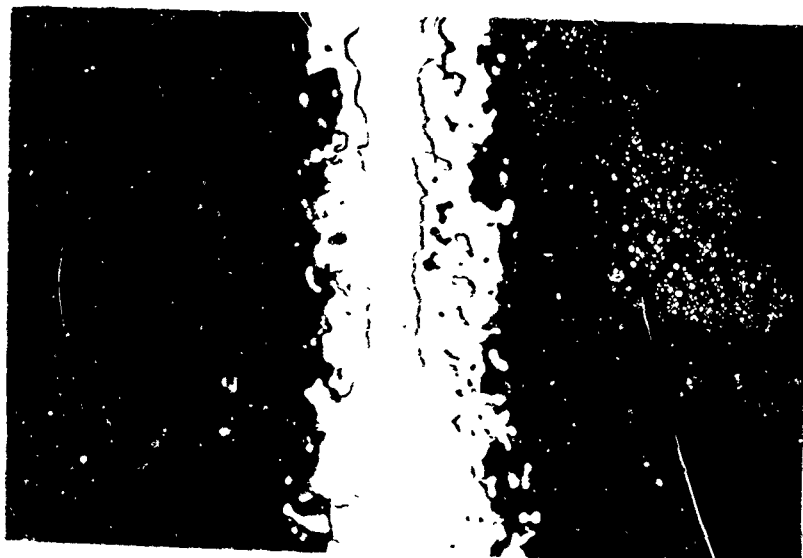
Variations in sintering temperature cause different metallizing interface structures. For example, Figure III-2 shows metallizing mix No. 1 sintered at three different temperatures. In the 1680°C sample, the interface is fractured; in the 1760°C sample, the interface is slightly modified but intact; while the 1855°C sample shows no apparent interface reaction zone.

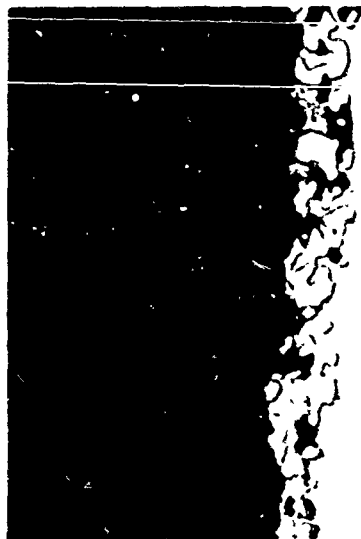
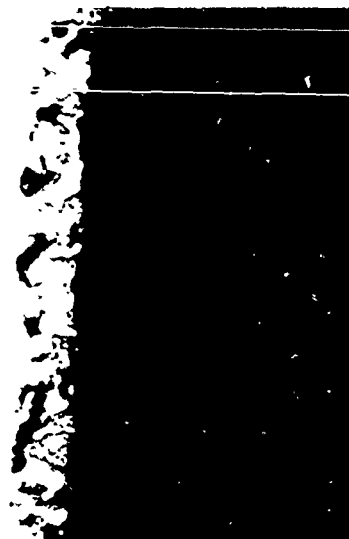
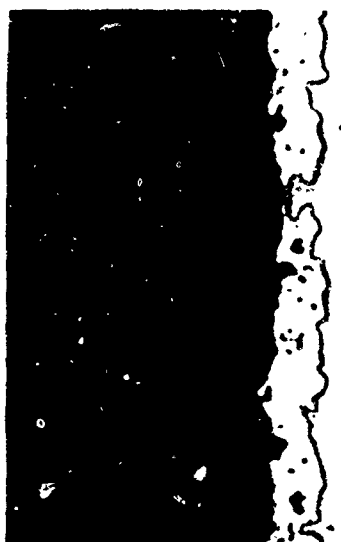
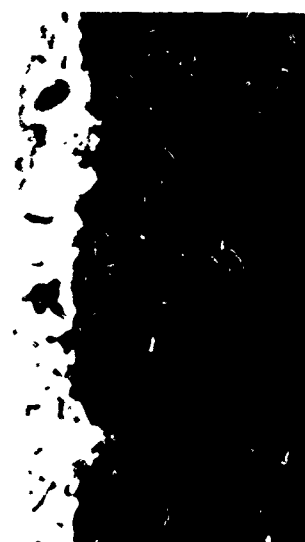
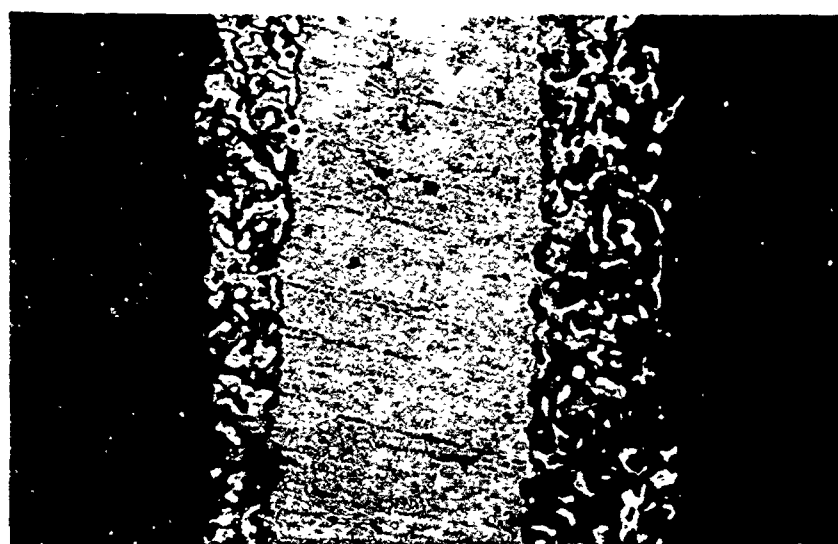
A

Mix No. 18

1800°C

Leaker

B

1900°C

Vacuum Tight

C

Mix No. 54

sintering temperatures ( $1850^{\circ}\text{C}$  and  $1900^{\circ}\text{C}$ ) required to eliminate interface failures, produced leak tight samples with the structure shown in Figure III-3B. This coating is similar to that of mix No. 1 sintered at  $1850^{\circ}\text{C}$  (Figure III-2C) in that both are very dense and show no interface region. It appears that all four of these compositions, when sintered at  $1850$  to  $1900^{\circ}\text{C}$ , result in the same structure and composition. Strength results discussed later will show that the dense metallizing was not weak as feared, but actually produced excellent strengths.

Metallizing mix No. 54 (Figure III-3C) did not produce leak-tight seals. Porosity in the metallizing resulted from the baria instability and adequate sintering of the molybdenum did not occur.

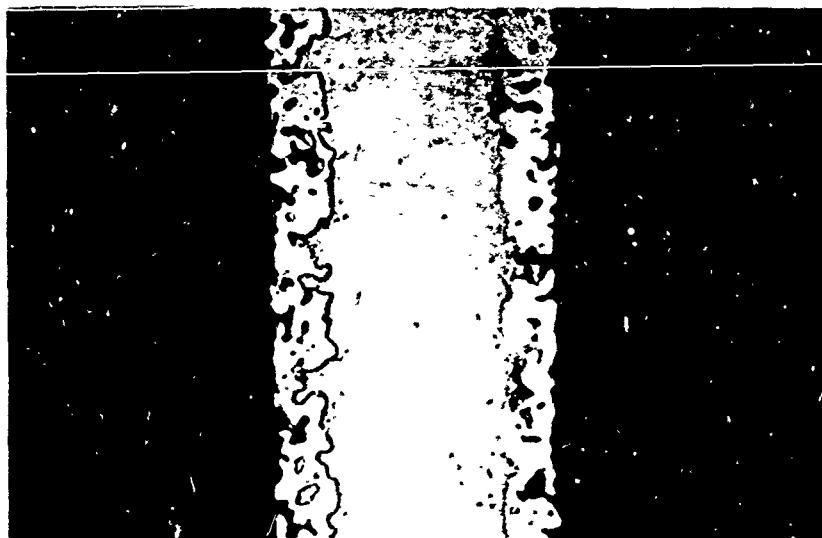
A                      Mix No. 55                      1800°C                      Vacuum Tight

Metallizing mix No. 55 (Figure III-4A) yielded excellent results. A desirably dense metallizing with no apparent interface was produced even at  $1800^{\circ}\text{C}$ .

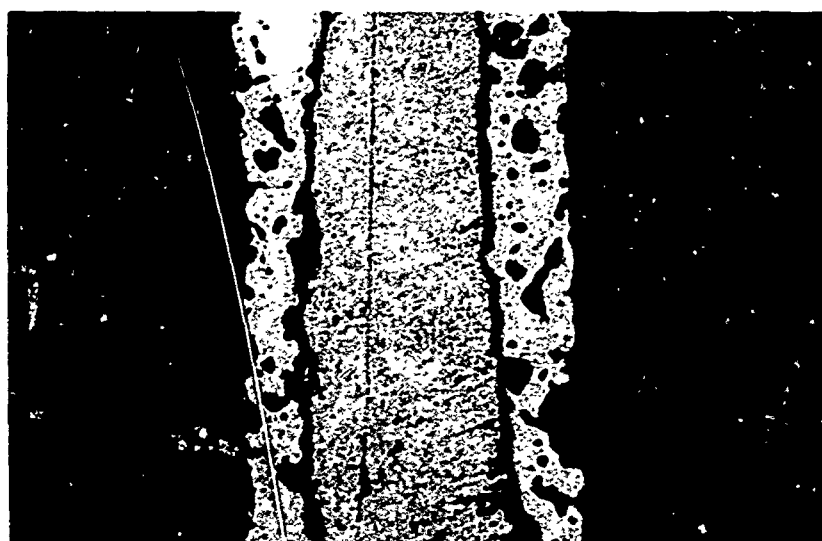
B                      Mix No. 56                      1890°C                      Vacuum Tight

It was reported by Cowan,<sup>4</sup> that a tungsten - 2 weight percent yttria metallizing produced good ceramic-metal seals. Mix No. 60 represents this composition while mix No. 56 represents a molybdenum counterpart. The leak check results given in Table III-1 should be considered in light of the fact that the nickel plate (0.1 mil) usually applied prior to copper-gold brazing had been omitted on these parts. It should be noted that the usual 30-40 v/o bonding oxide is not present in these two mixes. Mix No. 56 (Figure III-4B), with

approximately 5 v/o oxide, produced a very dense structure as a result of the reactivity of molybdenum and the low percentage of bonding oxide. Mix No. 60 (Figure III-4C), with approximately 10 v/o oxide, and the more refractory tungsten powder produced a dense two-phase metallizing. Interfacial compounds were not noted in either case. Further evaluation of these compositions is recommended.

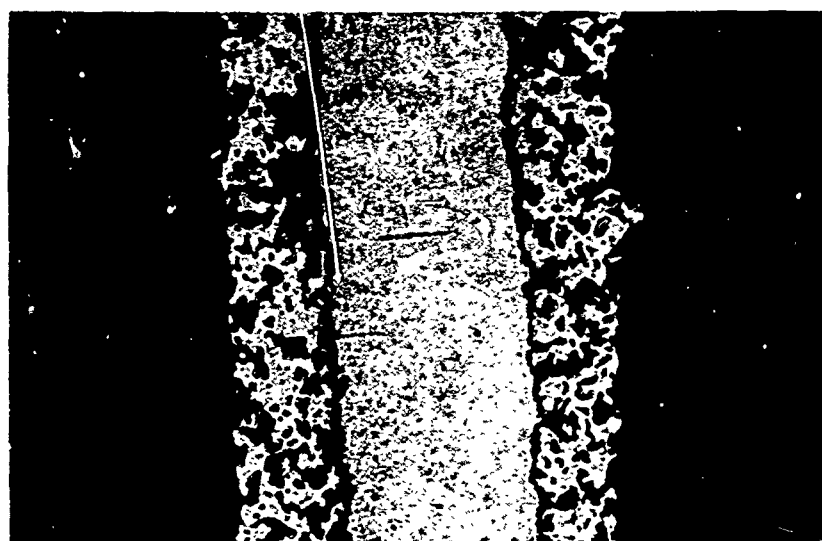
C                      Mix No. 60                      1890°C                      Vacuum Tight

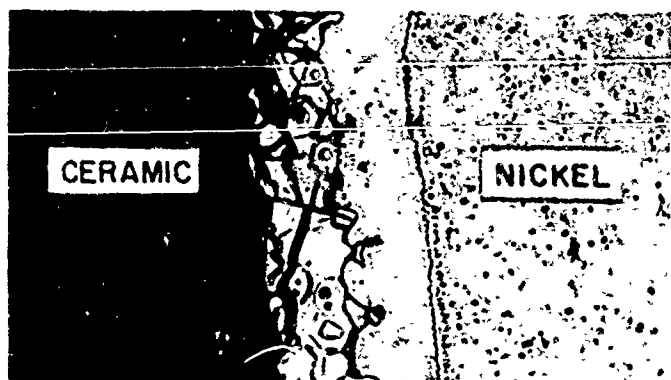
A 30 seconds at 1070°C

500X

Figure III-7 shows polished sections of alumina-to-nickel seals made at four different sealing temperatures. The seals were made to 0.010-inch thick SP nickel washers using 0.0005-inch titanium foil to form a liquid phase at the sealing temperature.

The titanium-nickel phase diagram, Figure III-8, shows that the first liquid to form would have the composition of the lowest melting eutectic, 71.5 w/o titanium, 28.5 w/o nickel. As the temperature is raised, the melt dissolves more nickel and the composition drifts toward the composition of the brittle intermetallic compound  $\text{Ti}_2\text{Ni}$ . Figure III-7A shows the structure which is obtained when sealing is performed at a temperature of about  $1070^\circ\text{C}$ . The region next to the ceramic is predominately  $\text{Ti}_2\text{Ni}$  and contains many cracks. Equilibrium conditions are not, however, attained in such a seal because of the "infinite" supply of nickel in contact with the melt. This results in a layer of  $\text{TiNi}$  adjacent to the  $\text{Ti}_2\text{Ni}$  layer, at whose surface the aforementioned cracks terminate. A thin layer of  $\text{TiNi}_3$  lies between the  $\text{TiNi}$  and the Ni washer.  $\text{TiNi}_3$  is optically anisotropic and is readily identified using polarized light. Heating a seal to a temperature of  $1180^\circ\text{C}$ , slightly above the  $1118^\circ\text{C}$  eutectic, results in the structure shown in Figure III-7B. Here both  $\text{TiNi}$  and  $\text{TiNi}_3$  are seen, as predicted by the phase diagram.

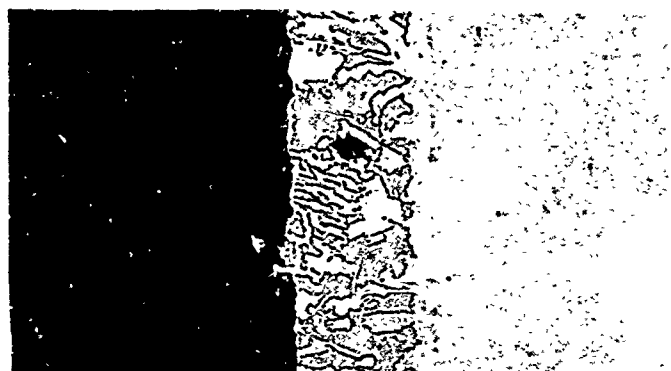
B 20 seconds at 1180°C

500X

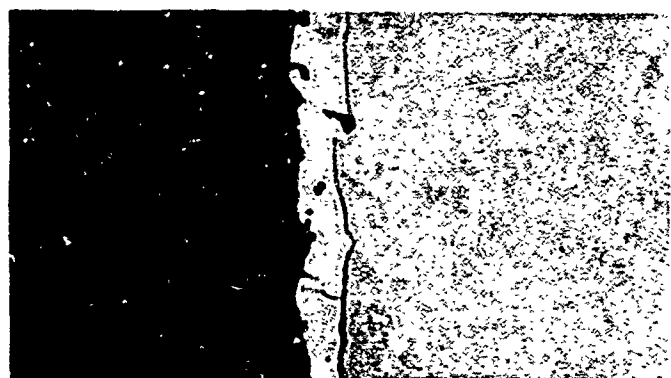
C 60 seconds at 1275°C

750X

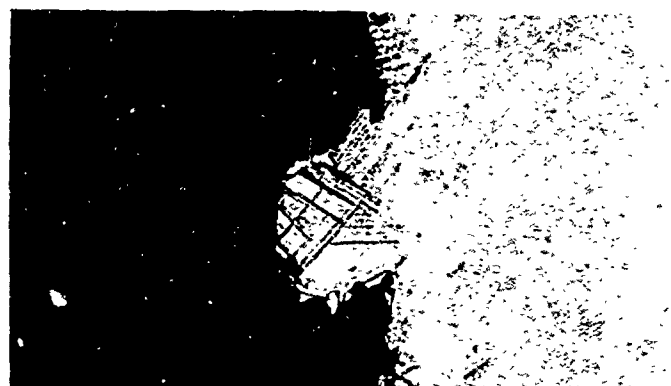
D 60 seconds at 1315°C

750X

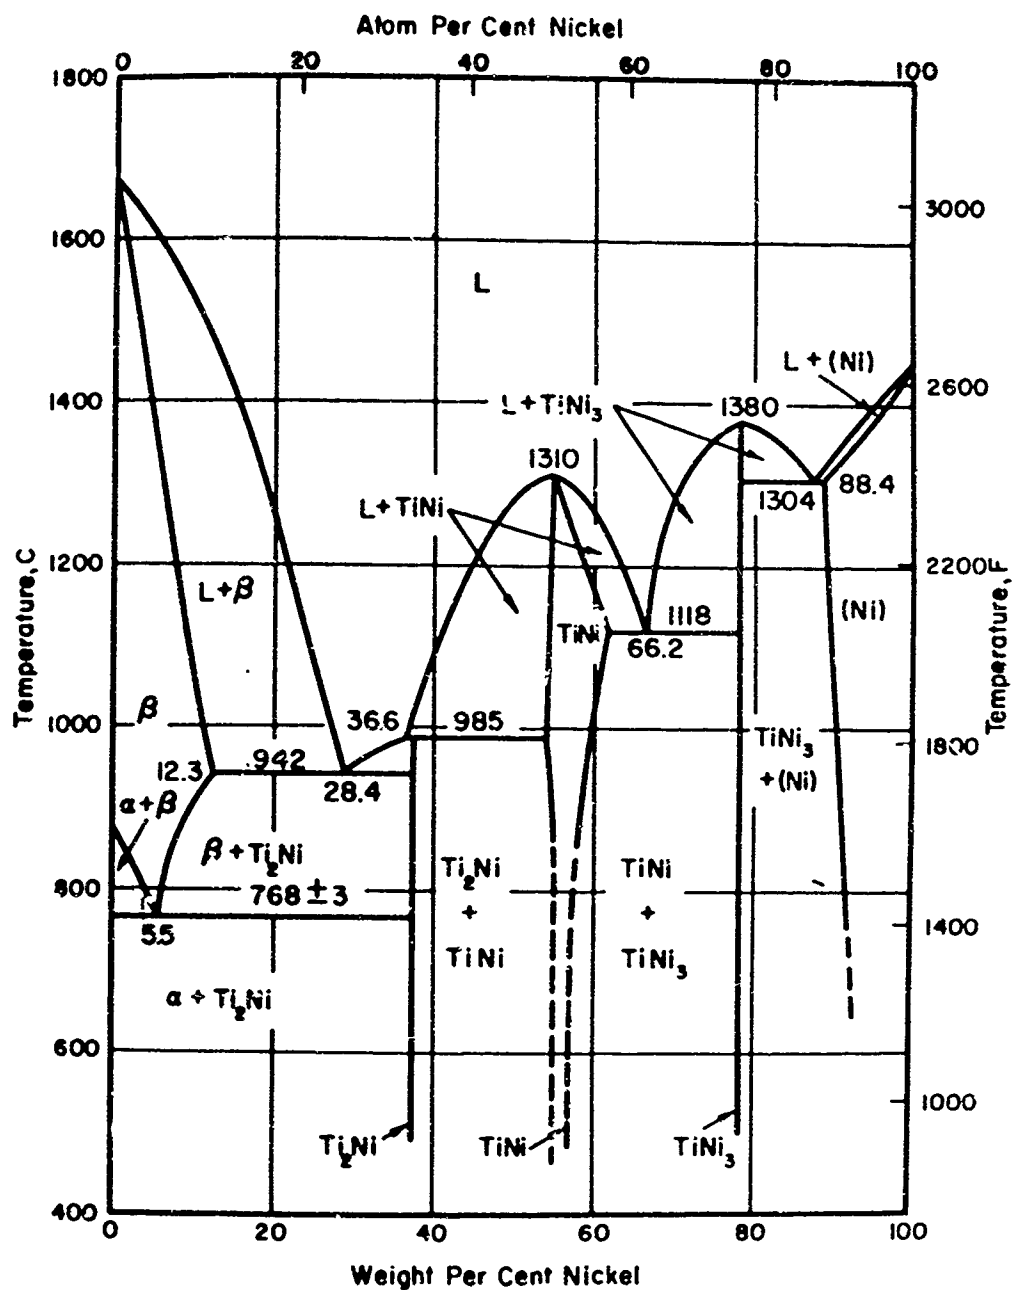
Figure III-8

Titanium-Nickel Phase Diagram<sup>42</sup>

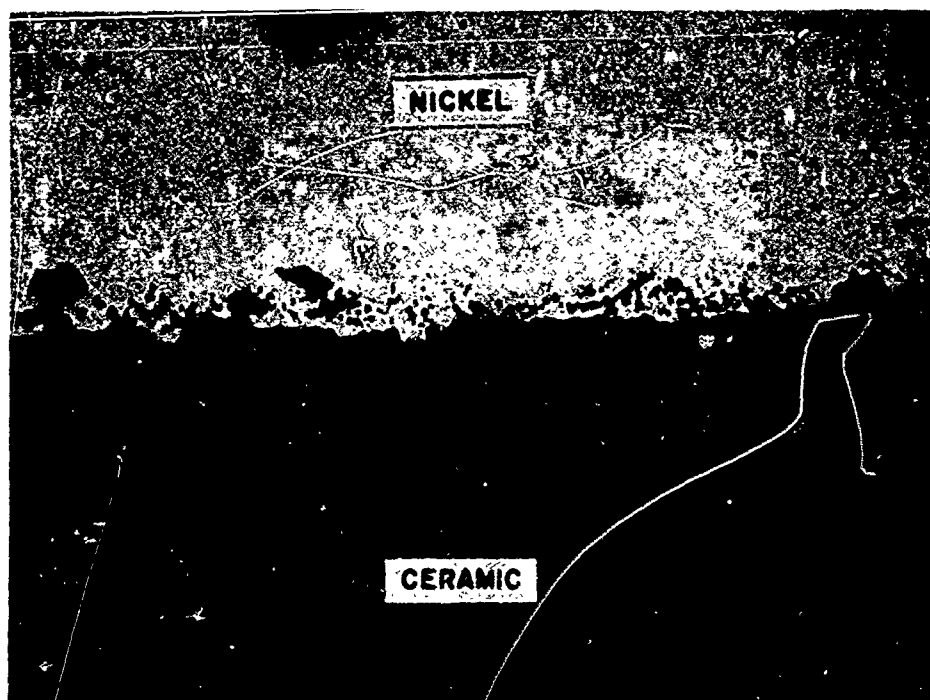
Figure III-9

Alumina-to-Nickel Seal After 1850 Hours at 900°C (500X)

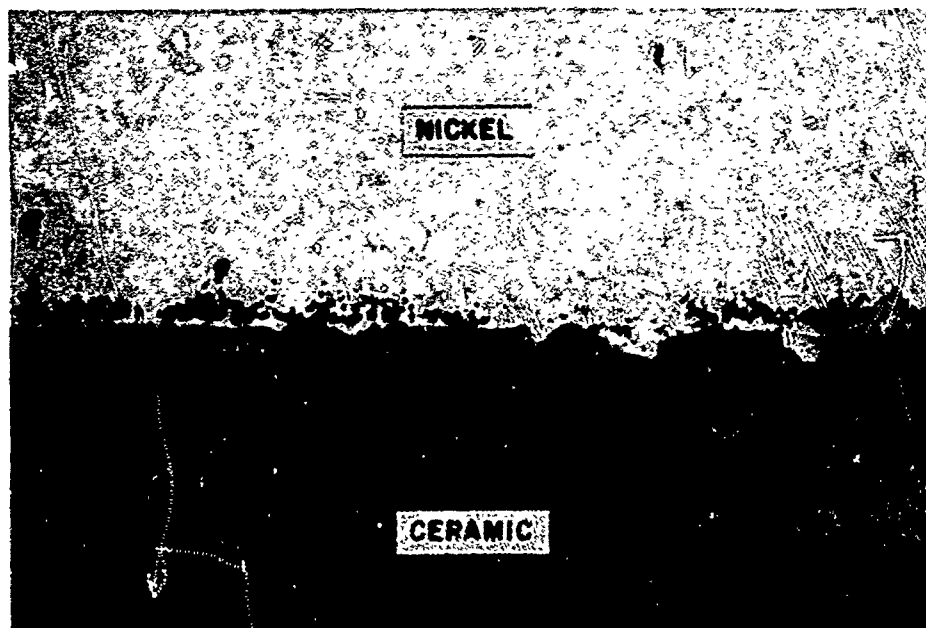
Figure III-10

Alumina-to-Nickel Seal After 2280 Hours at 900°C (500X)

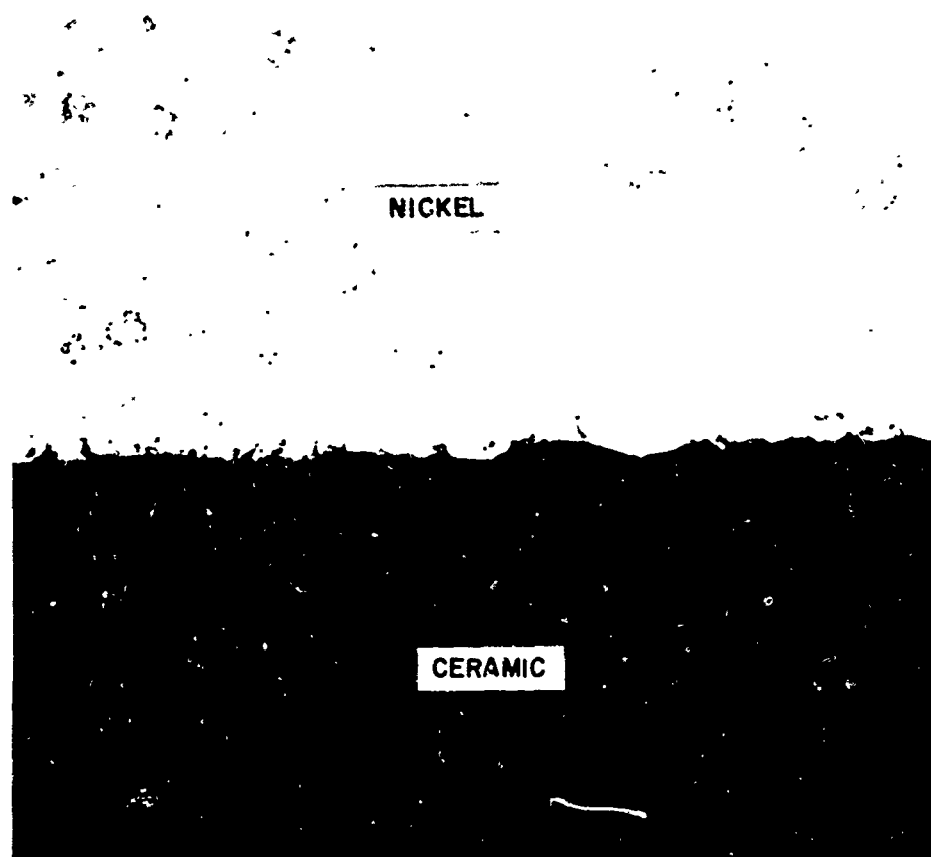
Figure III-11

In summary, the thermal cycling tests show that pure alumina-to-nickel seals (with  $\text{TiNi}_3$  at the interface) fail after a relatively few thermal cycles from room temperature to  $900^\circ\text{C}$ . Failure is believed to result from the mechanical stresses induced by thermal expansion mismatch between alumina, nickel and  $\text{TiNi}_3$ . Similar seals (to pure sintered alumina as well as 97-percent alumina) also fail when exposed to  $900^\circ\text{C}$  for long periods of time and generally show solutioning of the

Failure of Seal at Surface of Ceramic (500X)

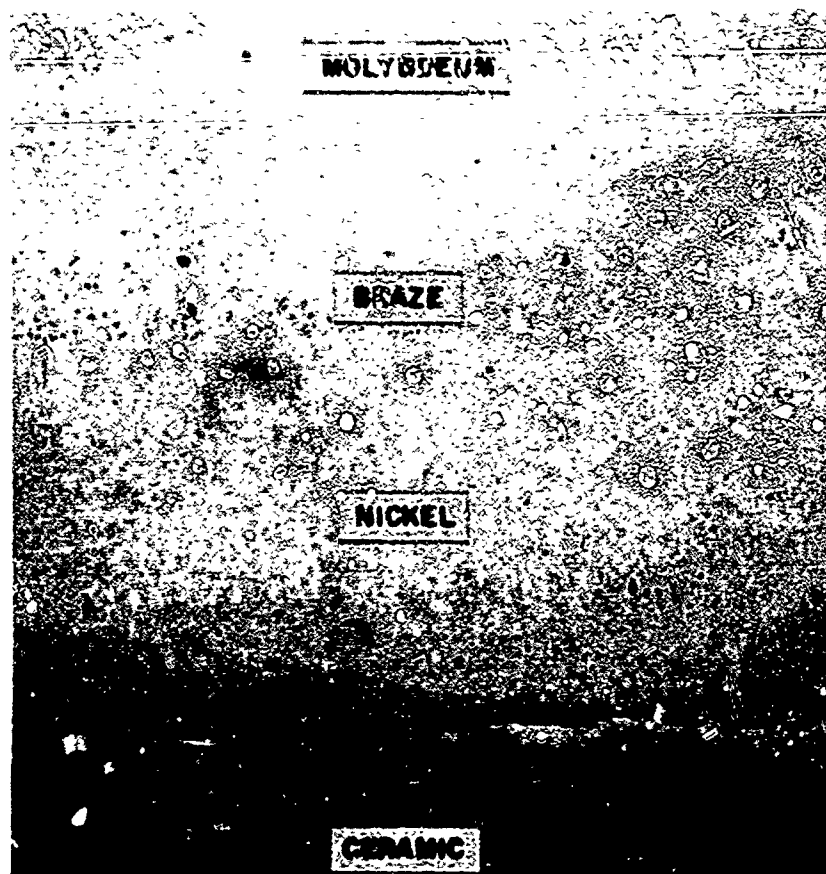
Alumina-to-Molybdenum Seal with Nickel Buffer Washers  
After 20 Thermal Cycles to 900°C (500X)

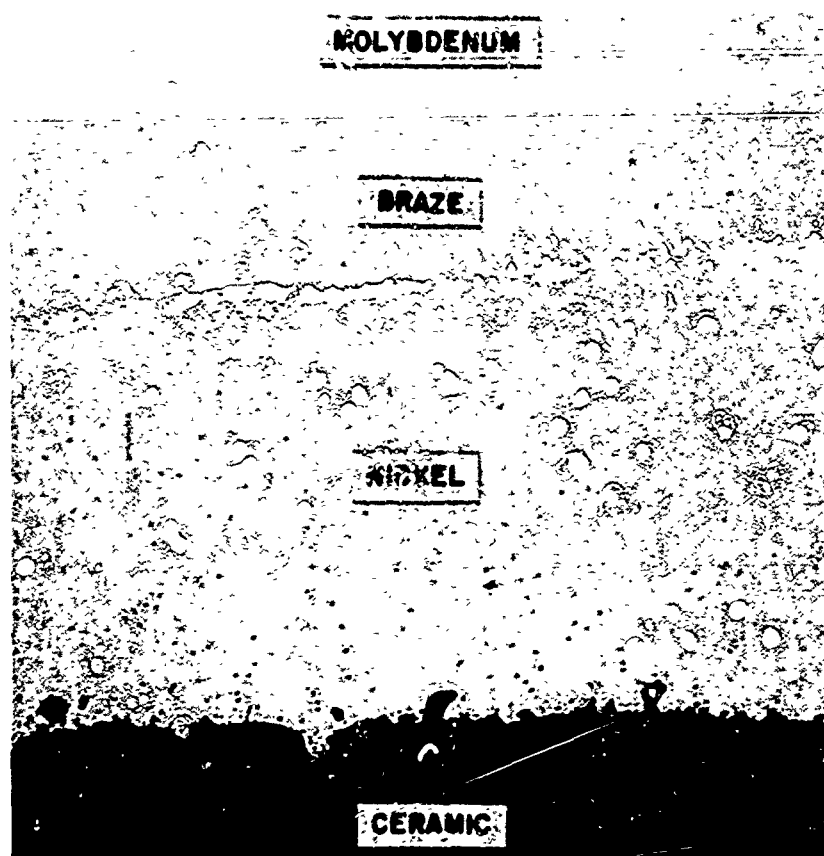
Life testing of several seals of each type to  $1075^\circ\text{C}$  resulted in no failures among the seals to molybdenum but total failure of the seals to tantalum. Figure III-14 is a photomicrograph of one of the vacuum-tight seals to molybdenum after 240 hours at  $1075^\circ\text{C}$ . Loss of the  $\text{TiNi}_3$  layer at the interface, due to solutioning by the nickel buffer washer, can be seen, as can the changes which occurred in the braze region between the nickel buffer washer and the molybdenum. Figure III-15 shows one of the seals to tantalum which failed. Diffusion at the interface between the nickel buffer washer and the

Alumina-to-Molybdenum Seal with Nickel Buffer Washers  
After 240 Hours at 1075°C (500X)

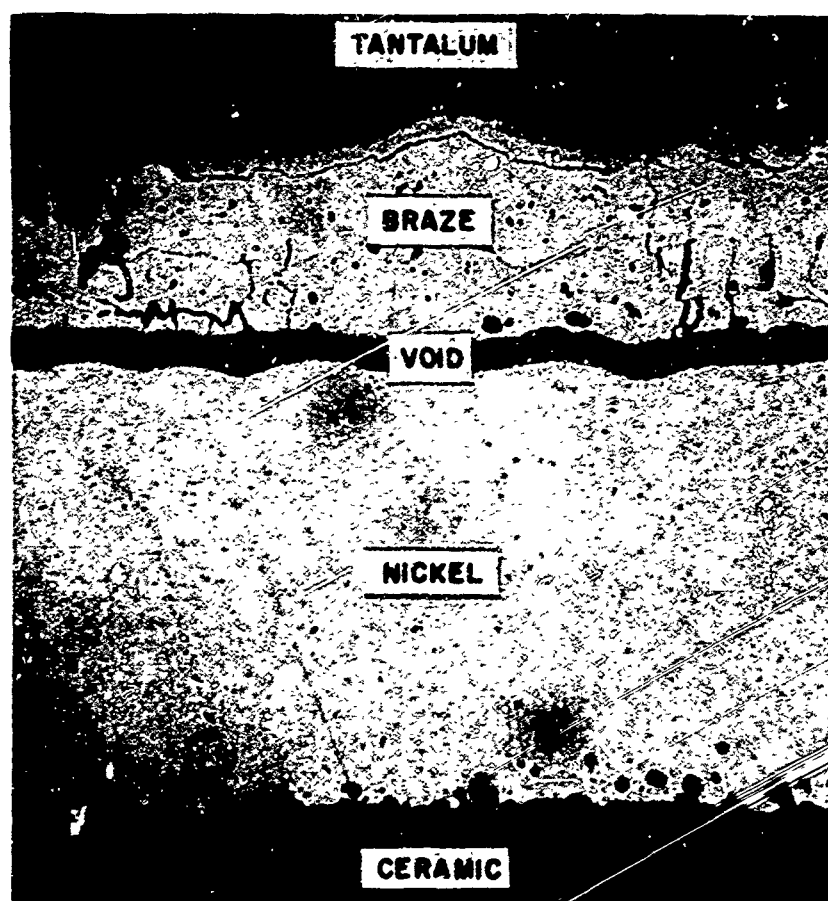
Figure III-15

Alumina-to-Tantalum Seal with Nickel Buffer Washers  
After 240 Hours at 1075°C (500X)

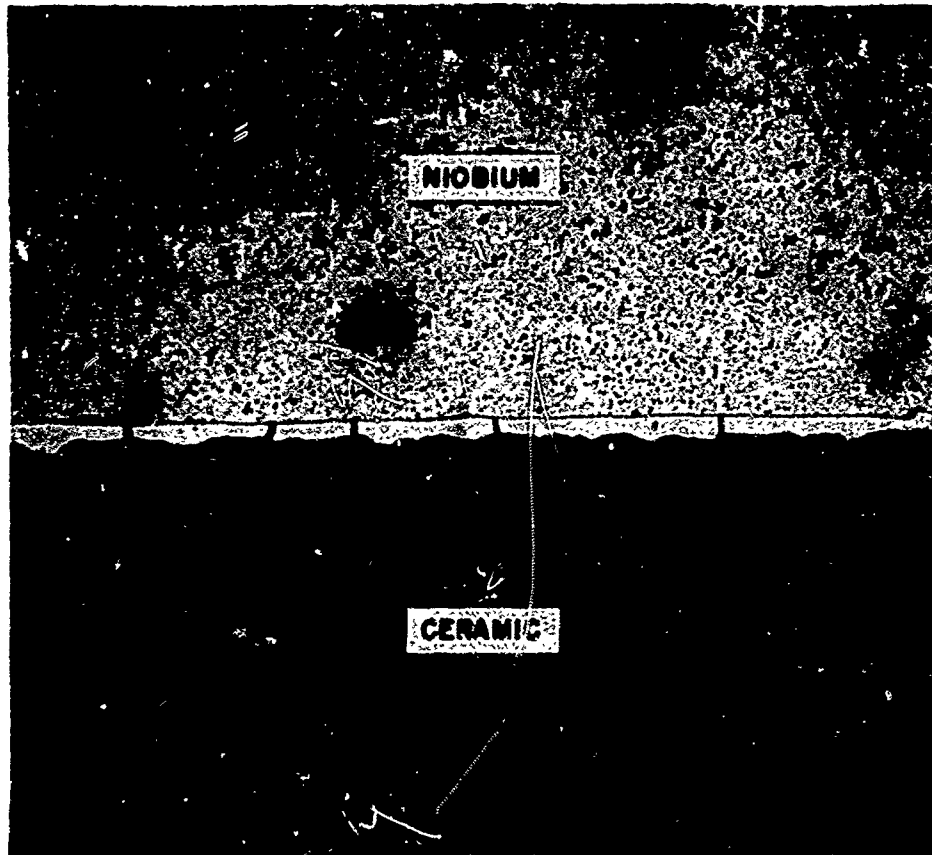
Alumina-to-niobium seals were prepared with many different time-temperature sealing conditions in order to assess the effect of sealing parameters on seal strength, vacuum tightness, and structure of the alloy which was formed. Figure III-16 is a photomicrograph of a seal which was made at a temperature of  $1430^{\circ}\text{C}$  with a two-minute soak. Seals made at other temperatures and with soak times up to ten minutes looked virtually identical. Although all of the polished sections showed many cracks through the intermetallic layer, all were vacuum tight. The width of the cracks which appear in the photomicrographs has been exaggerated by etching and, as mentioned previously, it is possible that these cracks are formed during preparation of the polished section. Since the phase equilibrium diagram for the nickel-niobium system is incomplete (see Figure III-19), identification of the intermetallic compounds formed at the interface was not attempted. Microhardness measurements were made, at the midpoints of the intermetallic layer and the niobium washer, on seals prepared with different time-temperature conditions. Sealing conditions ranged from  $1270^{\circ}\text{C}$  for two minutes, through  $1416^{\circ}\text{C}$  for ten minutes, to  $1433^{\circ}\text{C}$  for two minutes. Knoop hardness (10-gram load) of the several layers was virtually identical in all of the seals which were measured and averaged 150 KHN in the

Figure III-16  
Alumina-to-Niobium Seal Made at a Temperature of  
1430°C (500X)

niobium washer, and 680 KHN in the intermetallic layer.

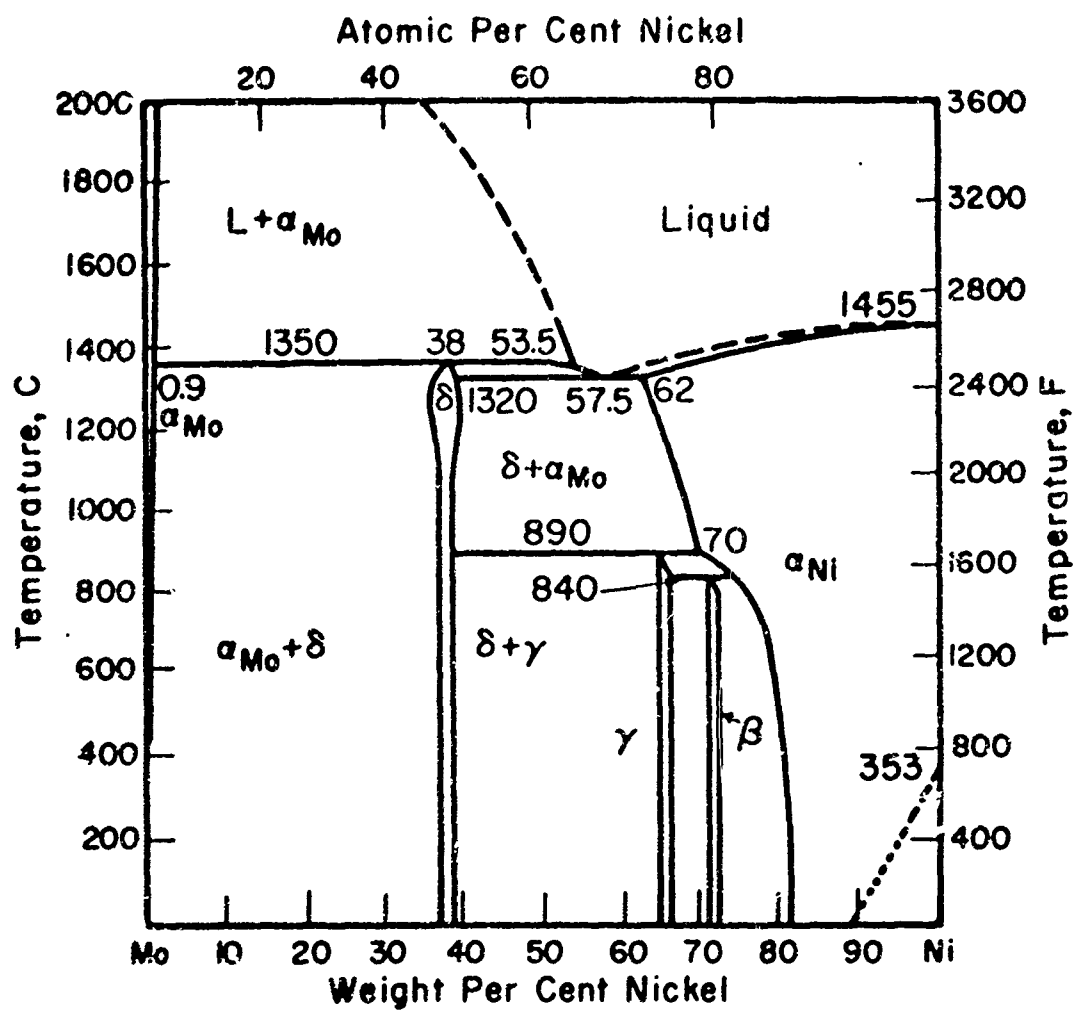
Figure III-18  
Molybdenum-Nickel Phase Diagram<sup>22</sup>

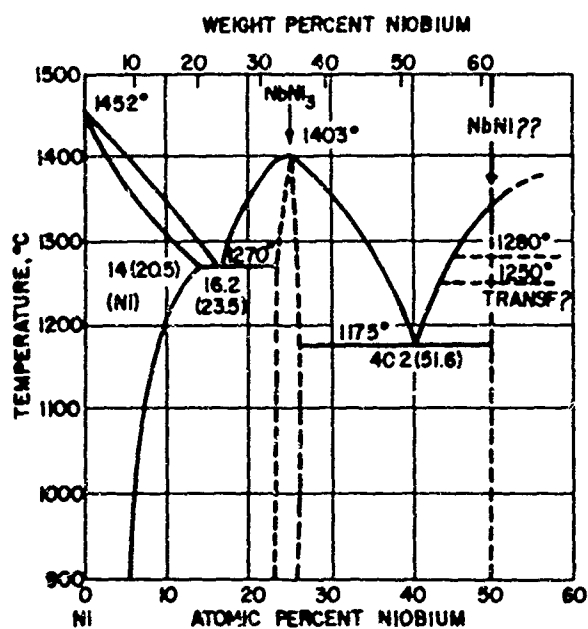
Figure III-19  
Nickel-Niobium Phase Diagram<sup>23</sup>

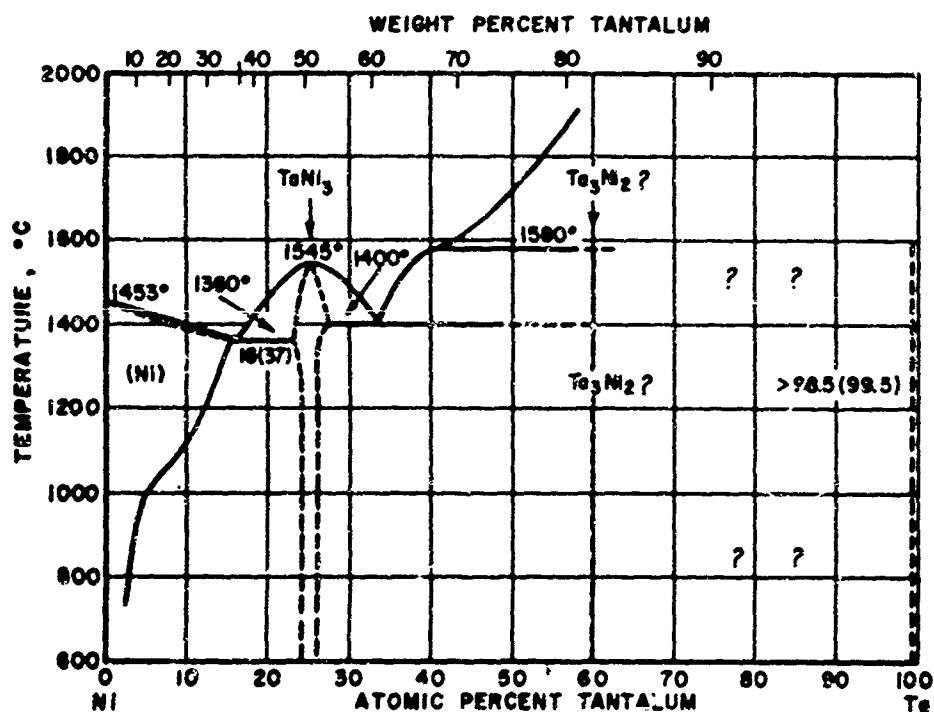
Figure III-20  
Nickel-Tantalum Phase Diagram<sup>24</sup>
